From Design to Disaster: Analysis of the Florida International University Pedestrian Bridge Collapse

Robert Sumwalt
January 30, 2020

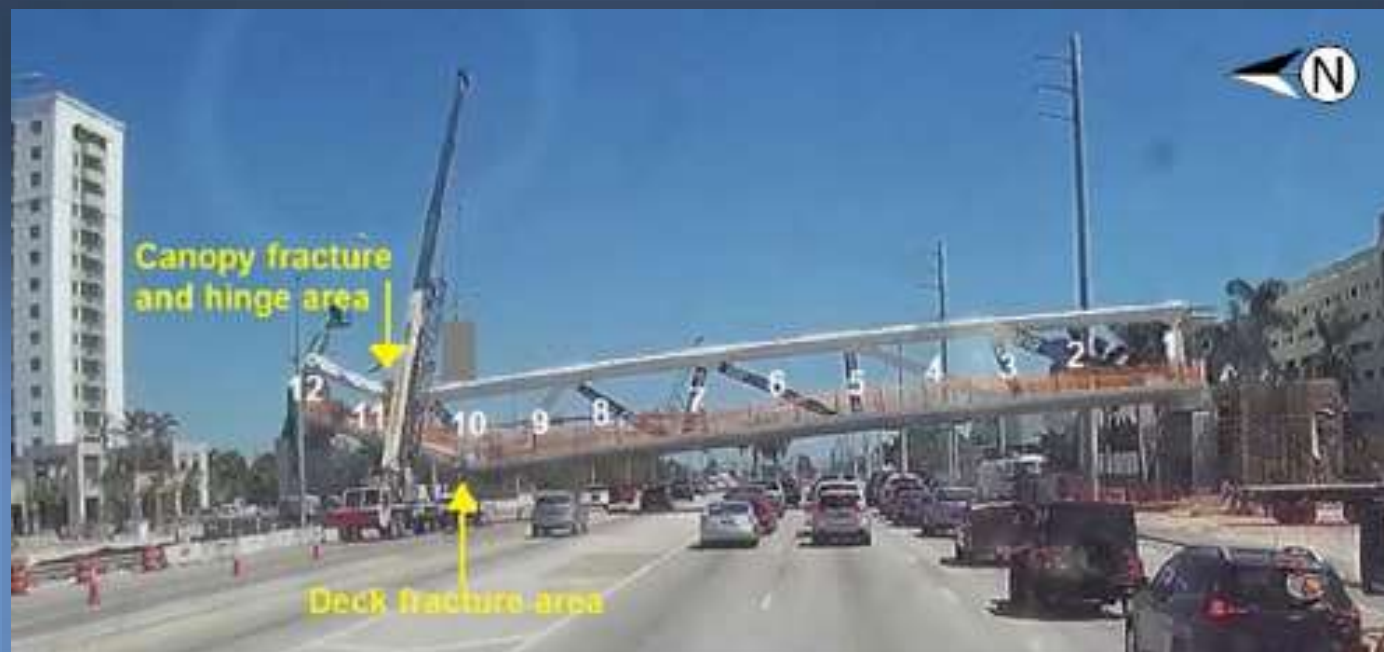
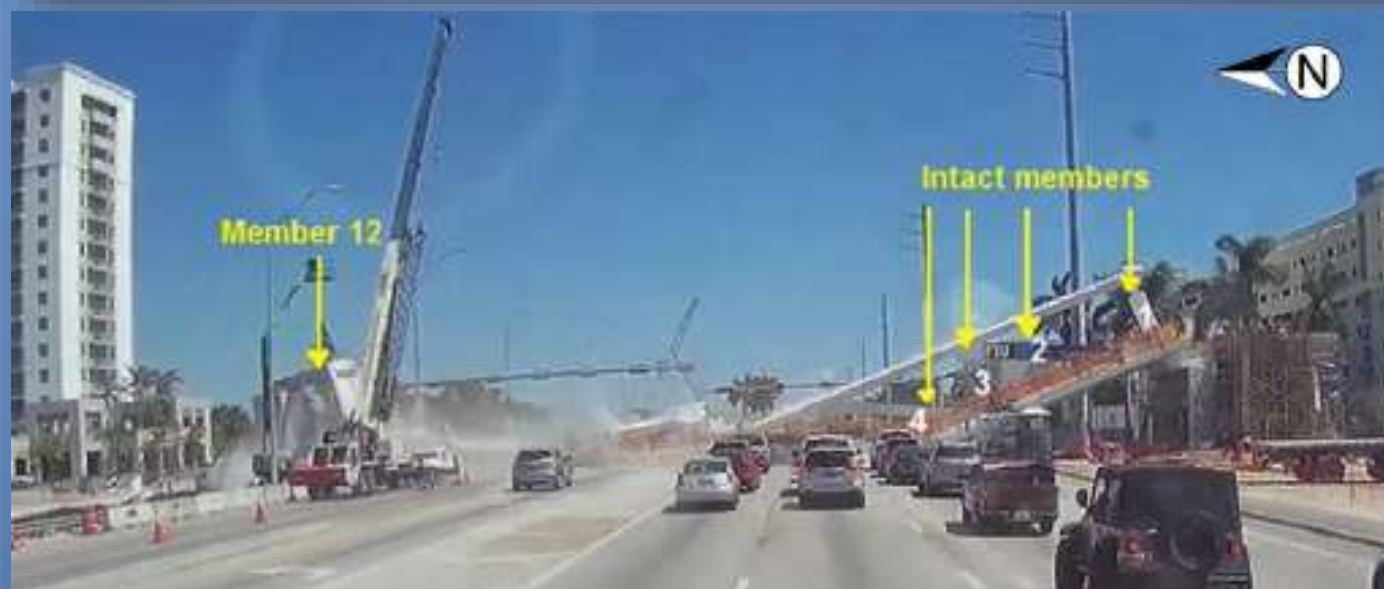
Facing East

Concrete
blowout

12 11
